## New DuraFin™ Heat Exchangers for Mining Vehicles

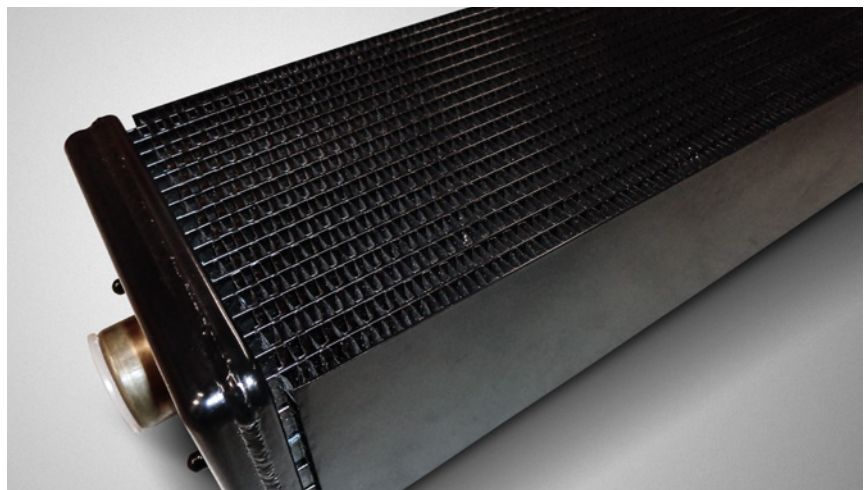
Fig. 2. Coated mid-size radiator with six tube rows. The black appearance of the tubes on the cross section in the right demonstrates the complete penetration of the coating through the core.

The selected coating was applied at first to small heat exchangers. After coating the heat exchanger cores were cut in pieces to check the penetration of the coating.

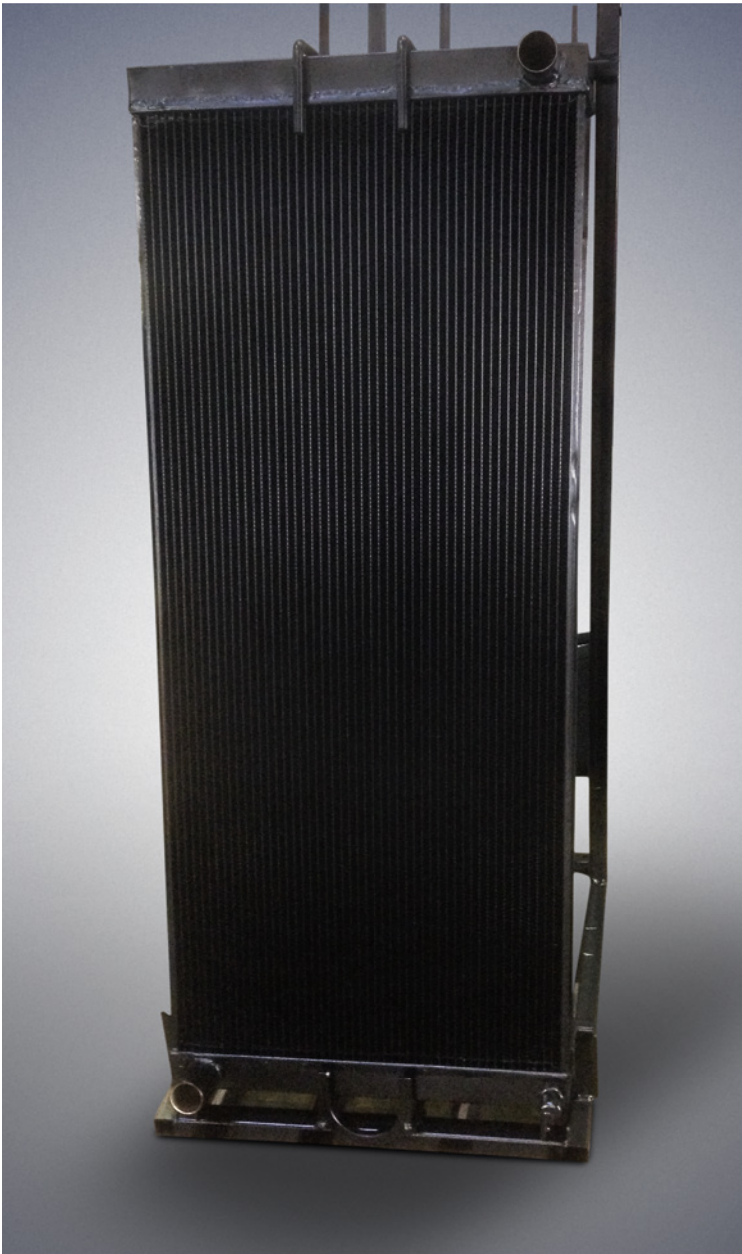
*Fig. 7. Full size DuraFin™ radiator on the coating rack designed for a mining vehicle*
